Utilisation of Poplar Lane Quarry (PLQ)

basecourse aggregate as a suitable

source for roading material

A thesis submitted in partial fulfilment
of the requirements for the
Degree of Masters of Science in Engineering Geology
at the
University of Canterbury
by
Clare Louise Dring

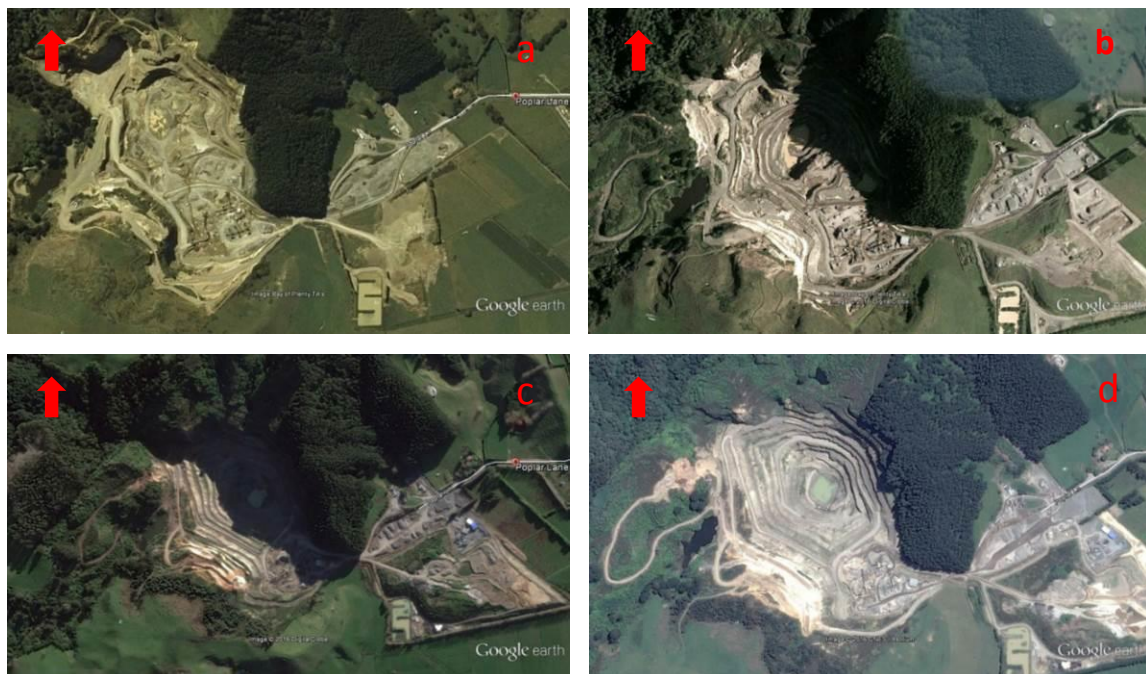
Figure 3.1 Left to Right Aerial image of Poplar lane Quarry a). taken on 01/12/2002, b). taken on 14/02/2007, c). taken on 15/06/2015 and d). taken on date 11/05/2016. All images extracted from Google Earth

Aerial photography of the quarry was easy to access with the publication of Google Earth Images (Figure 3.1.). The progression of the quarry pit was observed from images dating back to 2002 until the last image in 2015, where the pit is RL-45 (45m below sea level). This indicated the expansion of the quarry both laterally and vertically, and can be correlated with the geological map (Riley Consultants 2008) discussed in section 4.3.3.

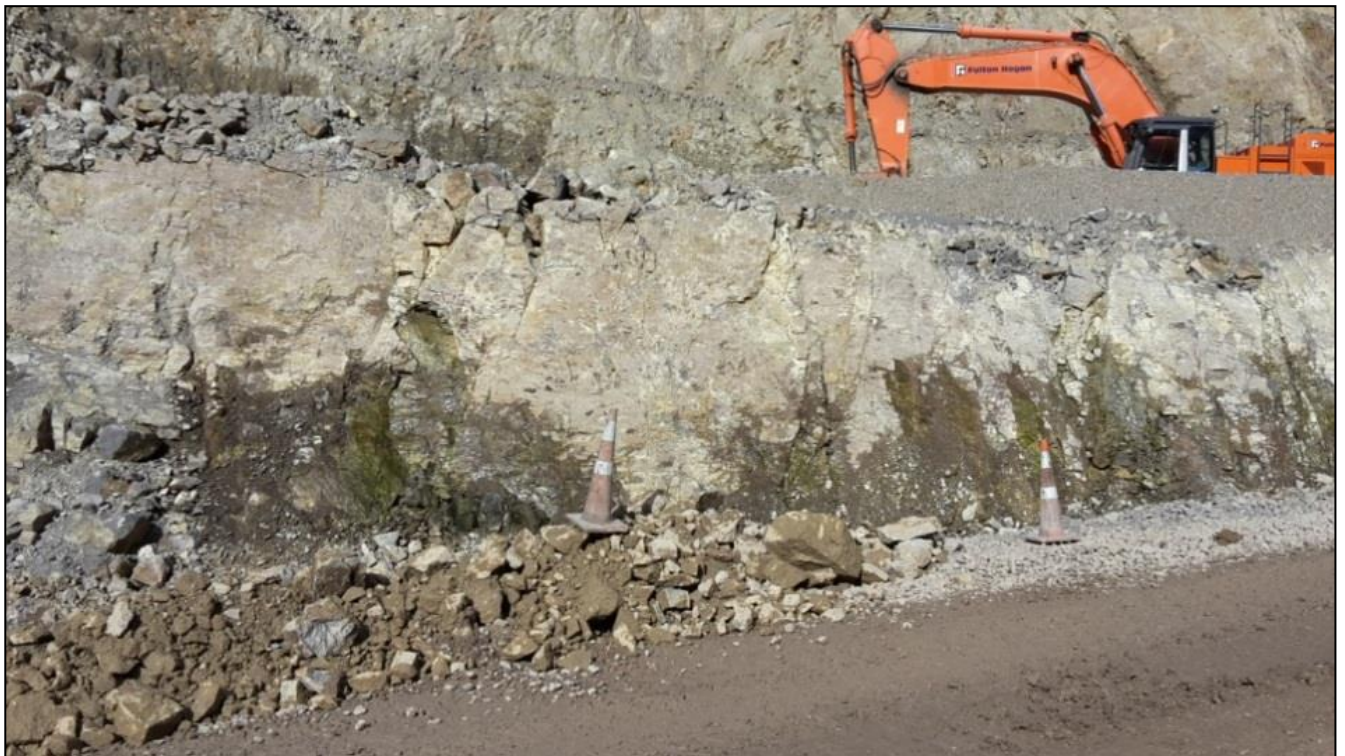
Figure 3.5 South East facing T-Grade site after material was hauled to the processing plant. Large blocky like material with smaller blocky material near larger fractures

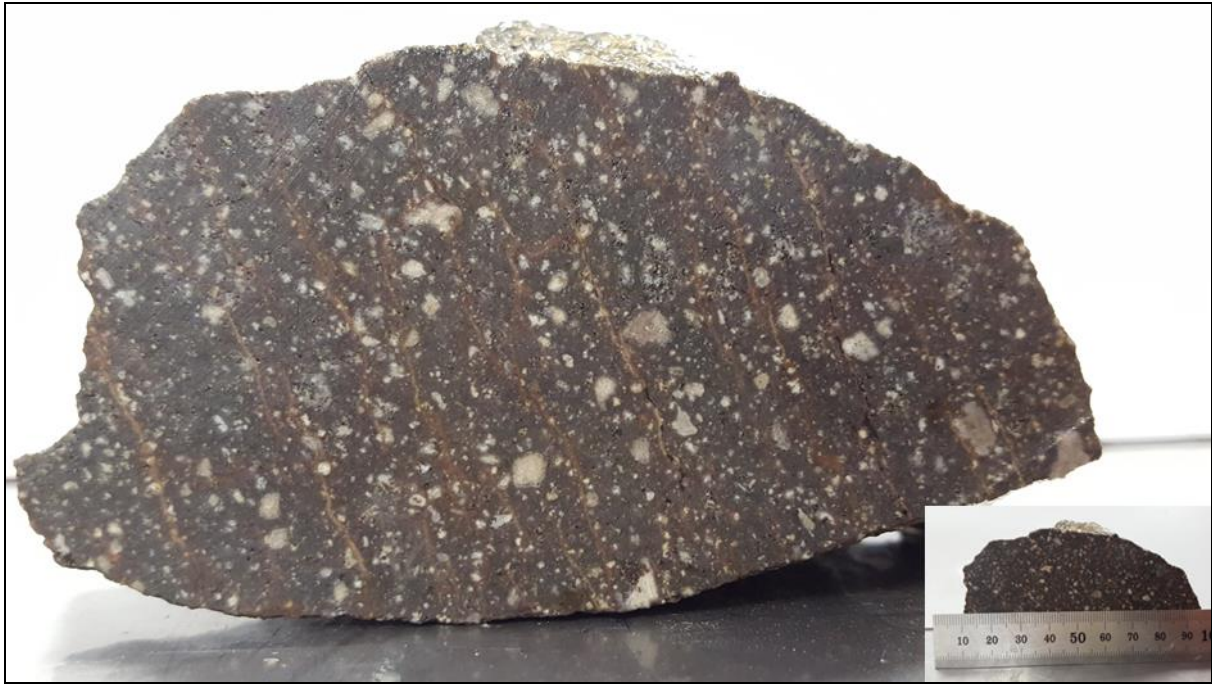
Figure 3.7 T-Grade material hand sample, note the lineation of veins and micro fractures. Large minerals are phenocrysts of k-feldspar, plagioclase feldspars and pyroxenes

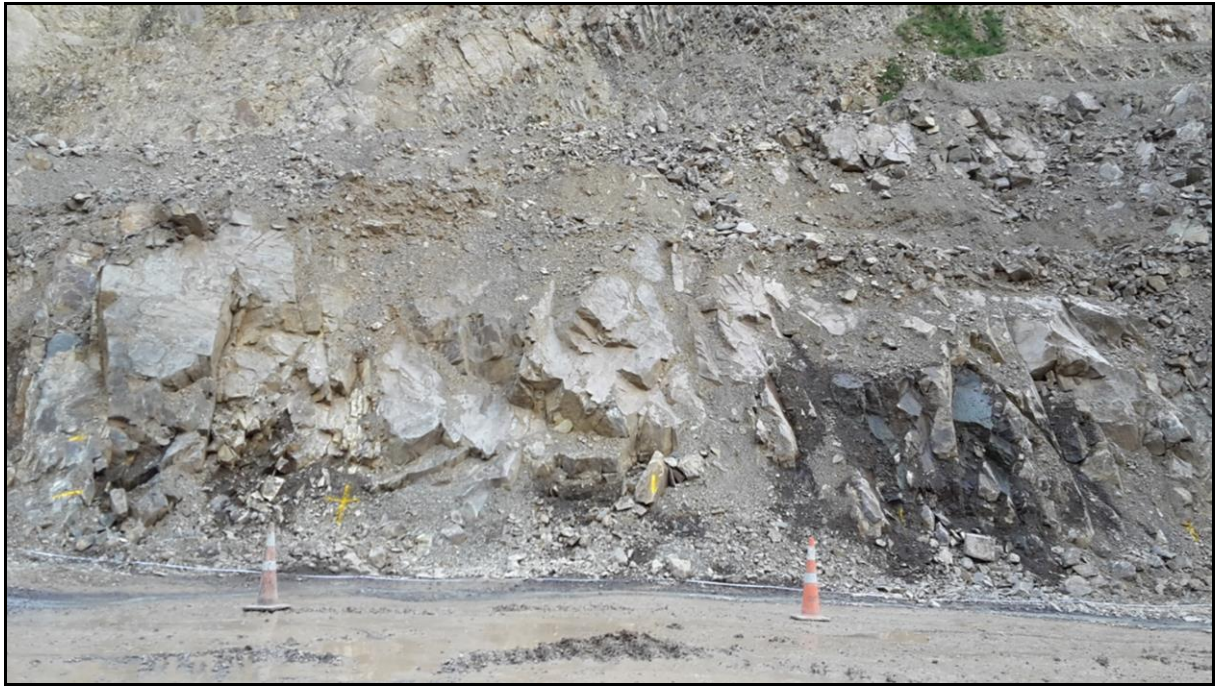
Figure 3.8 South West facing C-Grade site after material was hauled to the processing plant. Yellow lines indicate 5m intervals along the face used for mapping purposes.

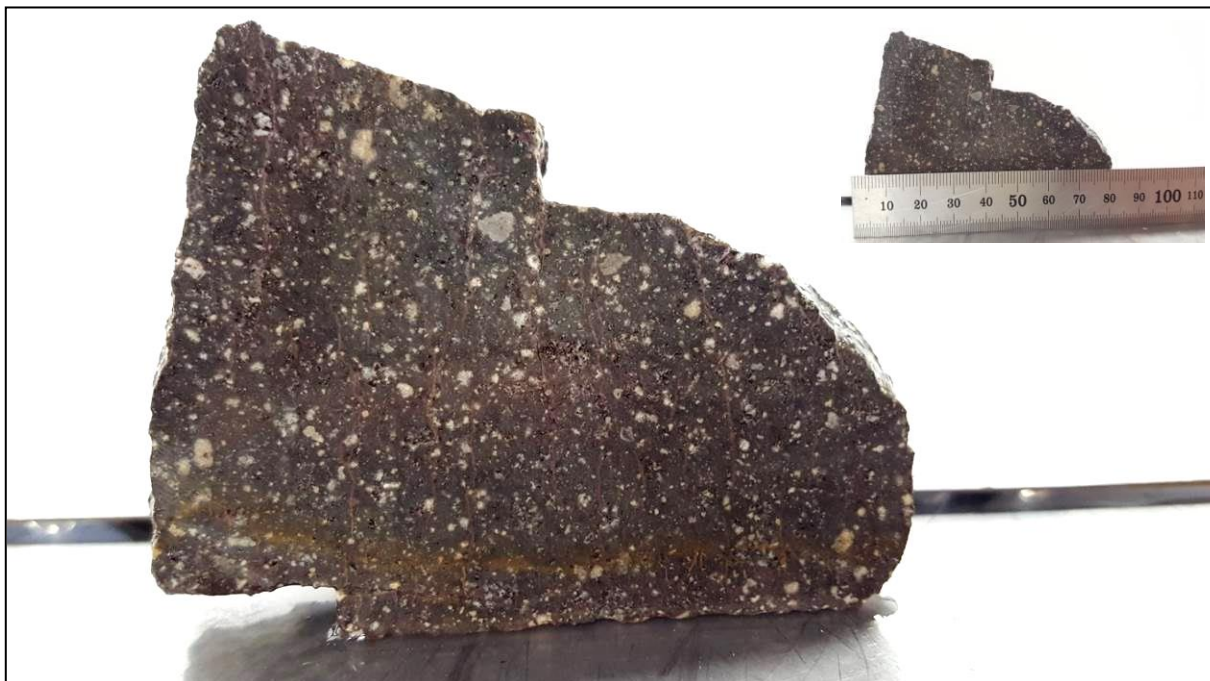
Figure 3.9 C-Grade material hand sample. Slight lineation of veins and micro fractures. Large crystals are phenocrysts of potassium feldspar, plagioclase feldspars and pyroxenes. Note the iron staining across the bottom of the sample which does not follow an obvious micro-fracture

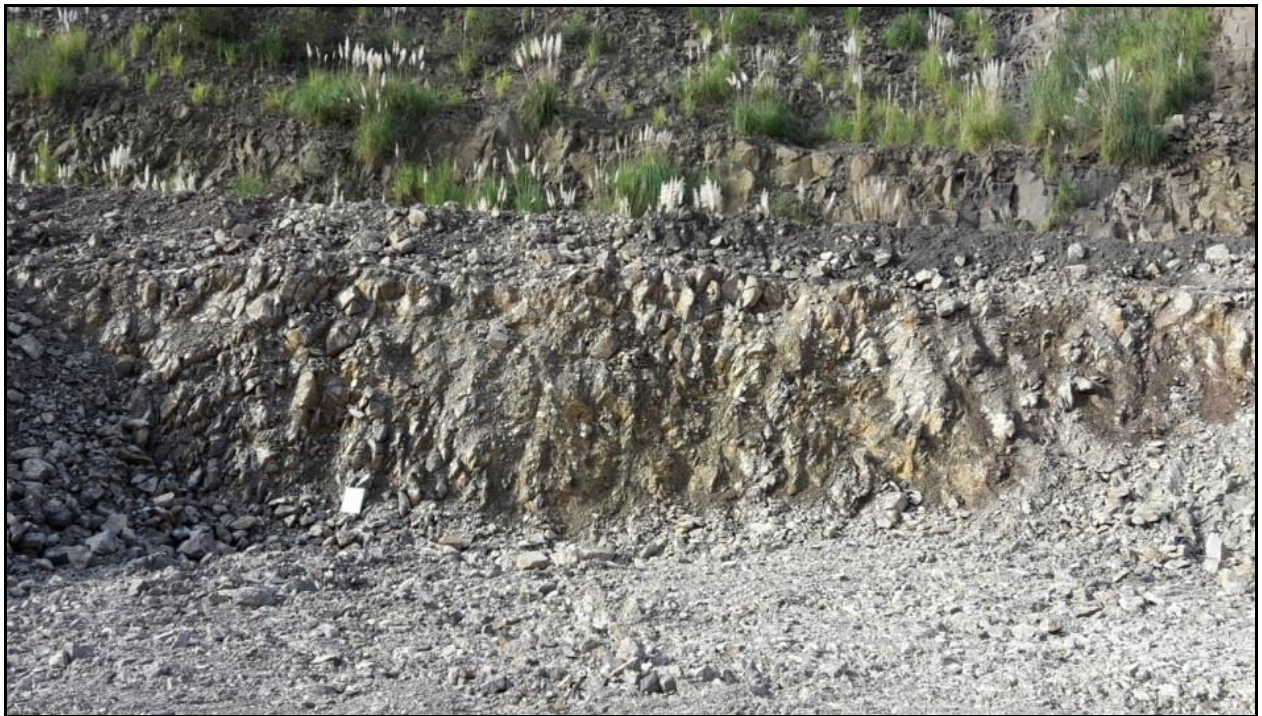
Figure 3.11 East facing G-Grade site after material was hauled to processing plant. Highly fracture material with loose rubbly material throughout.

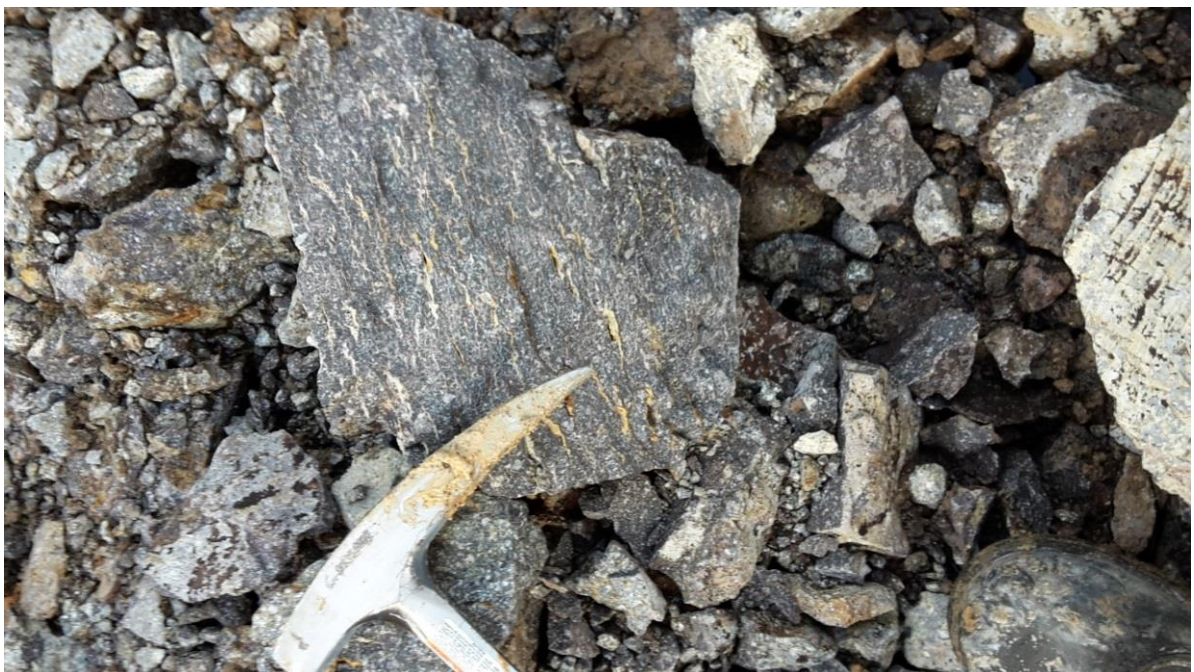
Figure 3.13 G-Grade material with micro-veins. Note the persistence and width with obvious in-filling of silty clay fines. Rock hammer used to show scale

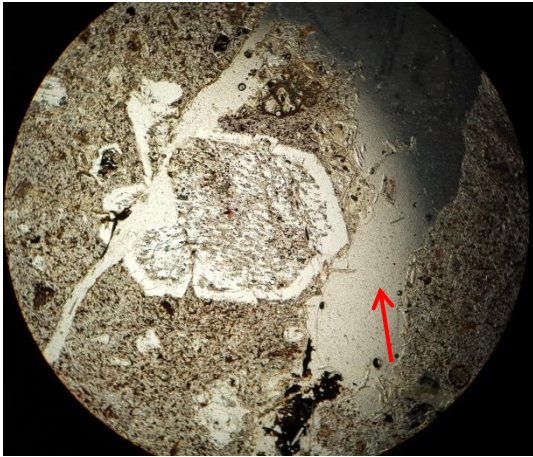
Figure 5.8 GB-4 sample x4 magnification in plane polarised illumination. Fracture through plagioclase mineral. Dissolution and zoning (red arrow). Large open fracture not in-filled (silver grey colour).

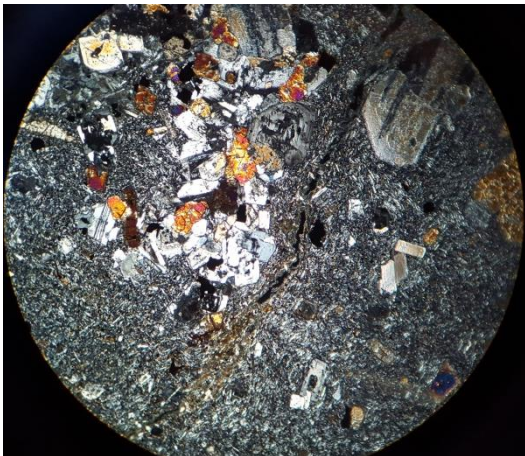
Figure 5.10 TB- 3 sample x4 magnification in cross-polarised-illumination. Micro-vein in-filled with microlite made up of plagioclase and pyroxenes, some iron staining. Glomeroporphyritic texture

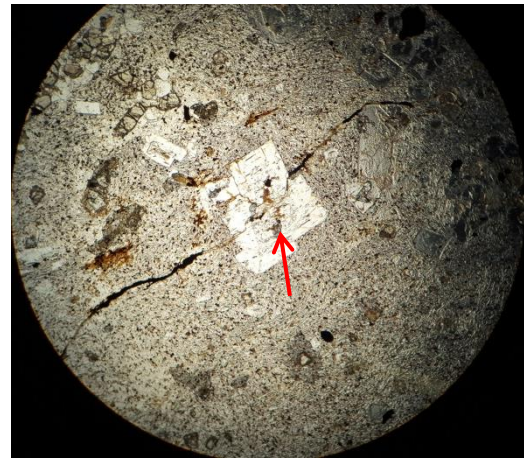
Figure 5.13 CB- 1 sample x4 magnification in plane polarised illumination. The plagioclase containing rock has undergone stress causing a fracture within the plagioclase (red arrow). This occurred after recrystallising.

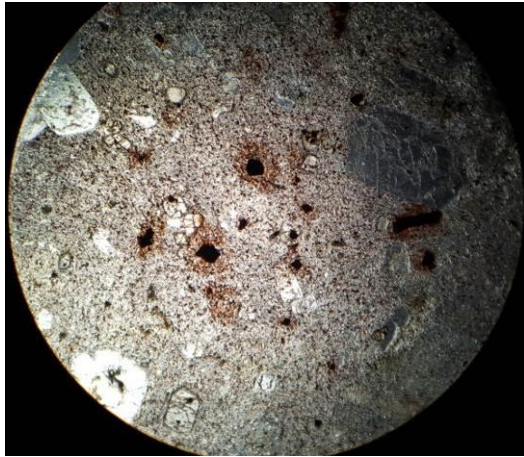
Figure 5.14 CA-3 sample x4 magnification in plane polarised illumination. Iron oxide stain surrounding cubic opaques shown by red arrows

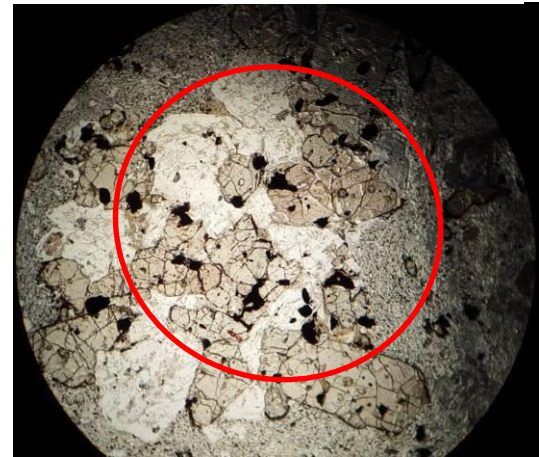
Figure 5.18 TA-3 sample x4 magnification in plane polarised illumination. Glomeroporphyritic texture, collection of minerals indicated by red circle.

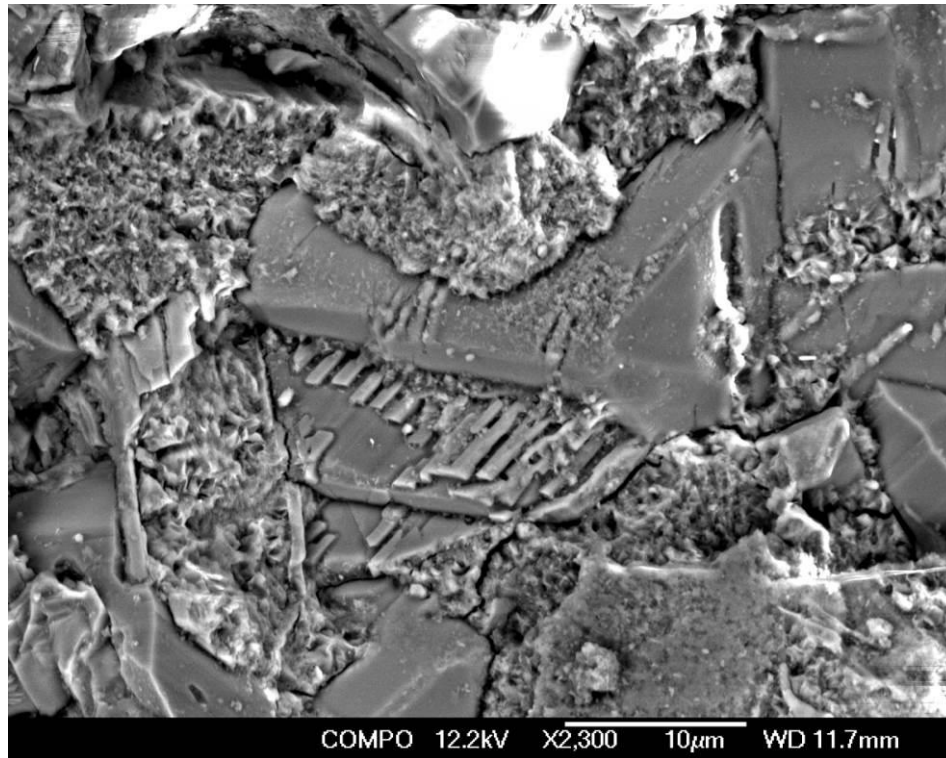
Figure 5.21 Image of sample W-02 under a scanning electron microscope in back scatter electron mode

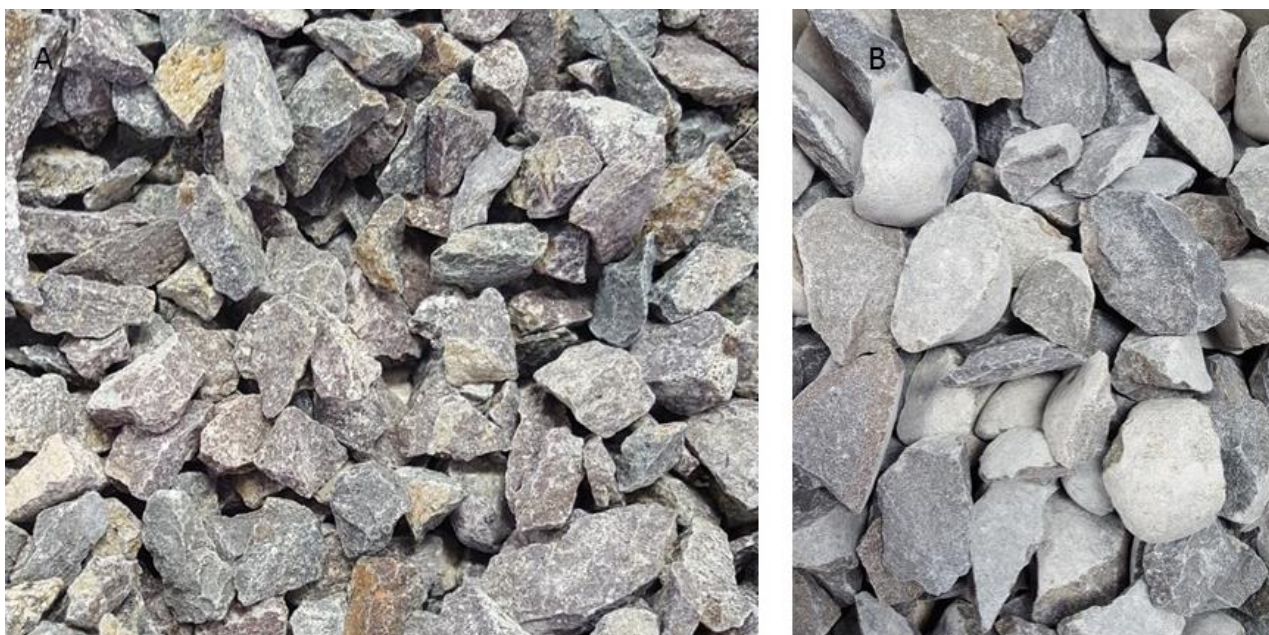
Figure C.1 Broken faces comparison. A. displays the broken faces from the PLQ hard rock quarry. B. displays the broken faces from the Canterbury greywacke control stone. Note how the Canterbury greywacke has some pieces with rounded edges. These rounded edges are not classified as broken faces

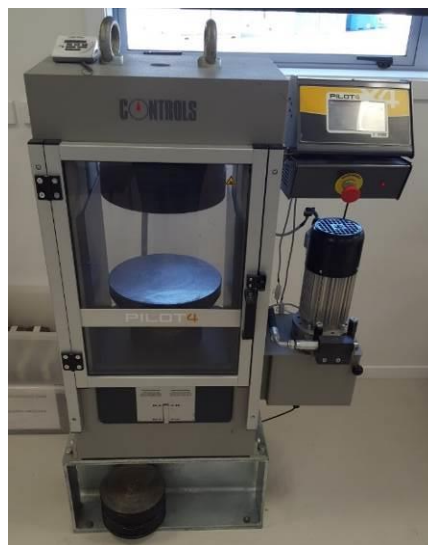
Figure D.1 CONTROL Pilot 4 automatic compression machine used in the testing of aggregates for crushing resistance

Crushing Resistance samples were wet sieved on site at PLQ, the 9.5 mm - 13.2 mm fraction was retained and bagged wet to be sent to Christchurch. On arrival in Christchurch the bags were re-sieved over the 9.5 mm fraction then washed and dried in a 110°C for testing. The Crushing Resistance mould was wiped with a dry cloth before use and tarred on balance. Roughly 3 kg was obtained for the test. The material was placed into the mould in three equal lifts, and at each lift the material was prodded with a tamping rod 25 times. A plunger lid is placed on the top; the mould is sufficiently filled when the plunger surface lies flush with the mould surface. It is then placed into the testing machine for testing. A CONTROL Pilot 4 automatic compression machine was used to apply the load (Figure D.1).

The specification requires that 130kN of load be applied to the material in 10 minutes. For this test speed was set 217N/s to achieve the require load over the specified time. At every minute the kN are recorded to ensure the load is reached within the required time frame. On completion of the load application the sample is removed and sieved over a 2.36mm sieve. These fines collected are

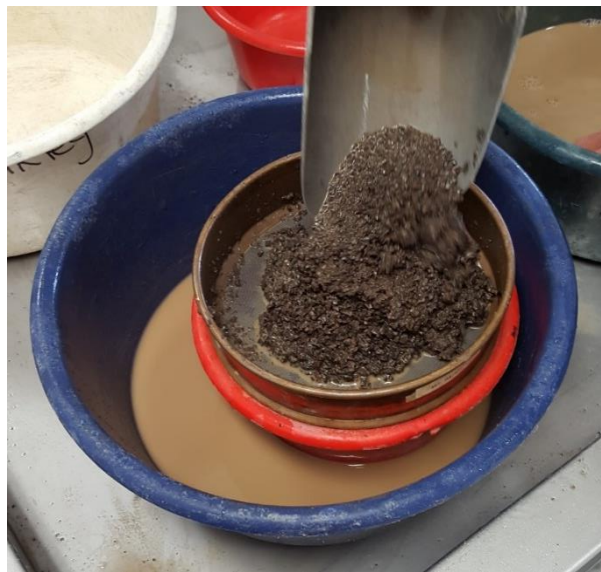
Figure D.2 Preparing the sample to obtain fraction passing the 4.25 μm sieve

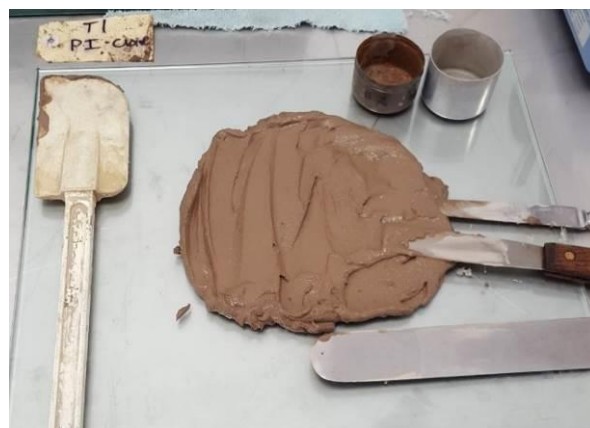
Figure D.3 Plasticity Index sample prepared and mixed to obtain correct moisture content
